## Parking Equity: Encouraging Reservation of Van-Designated Spaces for Lift- or Ramp-Equipped Van Users

Wheelchair users who travel in a ramp- or lift-equipped van (RLEV) often reach their destination only to find the van-accessible parking space occupied by a non-ramp or lift-equipped vehicle (NRLEV) that does not need the wider access aisle placed next to van-accessible spaces. This study found that alternate signage for van-accessible parking spaces can prompt drivers of vehicles without ramps or lifts to use a regular accessible space when available, reserving the van-accessible space for RLEV users.

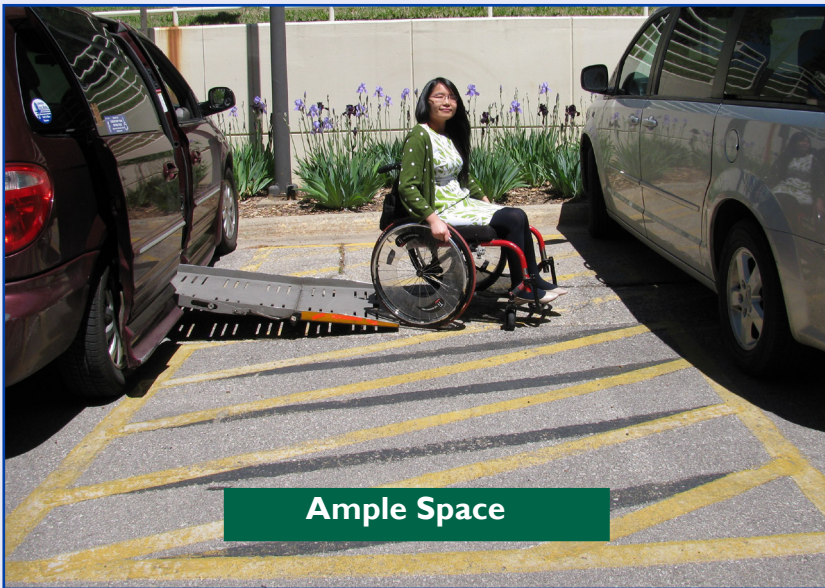
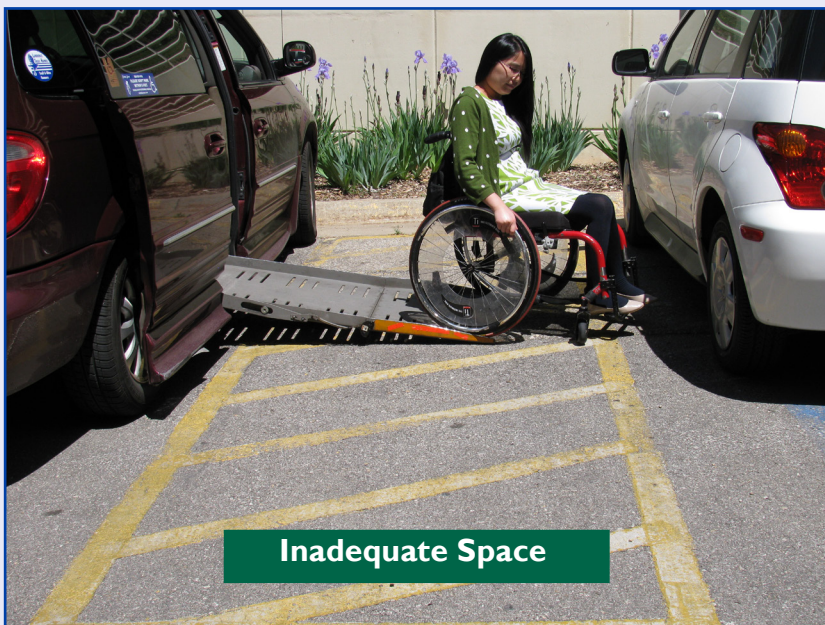
The photos below illustrate the purpose of van-accessible spaces. The wider aisle intended for an RLEV provides ample room for a wheelchair user to exit or enter the van and maneuver her wheelchair, without interference from the vehicle parked in the next space.

In contrast, the narrower access aisle next to a standard accessible space does not allow the user of a manual or power wheelchair to safely disembark. The individual could possibly injure her legs or feet on the neighboring vehicle, or damage her wheelchair tires by rolling over the edge of the ramp.

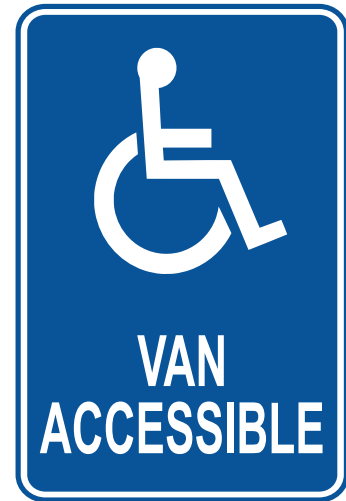
A sign with the words “Van Accessible” and the international symbol of accessibility (see *photo at right*) means the parking space is designed for ramp- or lift-equipped vehicles (RLEVs).

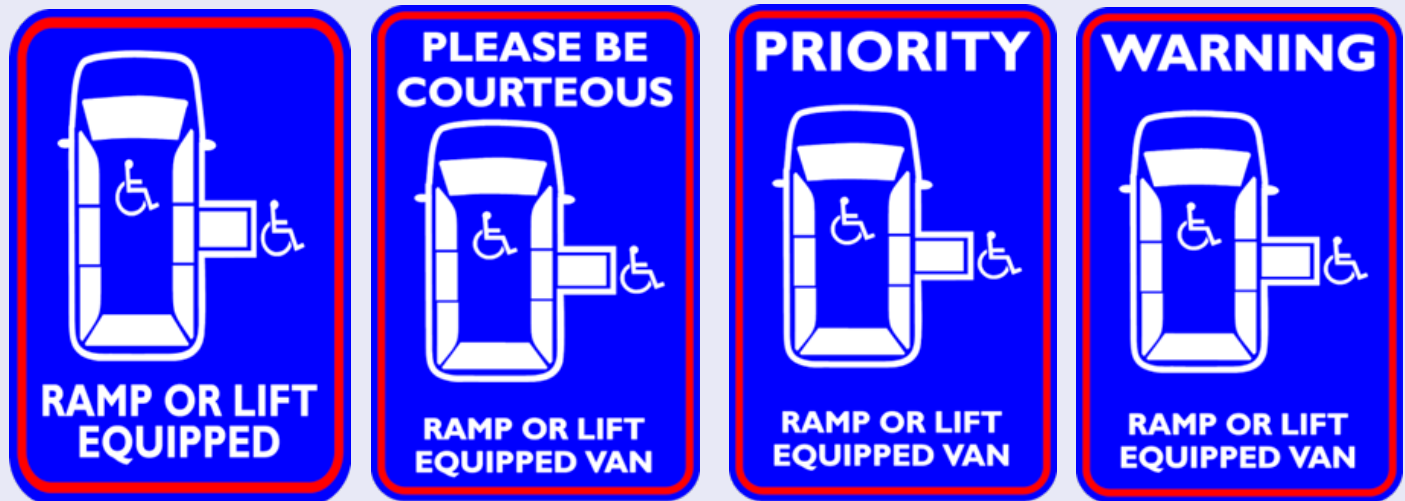
**Testing Alternate Signage:** This study compared the effects of the four different signs pictured above on NRLEV users at two grocery stores in a Midwestern city. The “Please Be Courteous” sign was most effective at one store while the “Warning” sign was most effective at the other.

All signs (*pictured above*) show a graphic of a van with the lift lowered and an icon of a wheelchair user inside the van and at the end of the ramp. One sign had the words “Ramp or Lift Equipped” only at the bottom. The other three signs had the words “Ramp or Lift Equipped Van” at the bottom of the sign, plus one of these messages at the top: “Please Be Courteous,” “Priority,” and “Warning.”

We conducted an experimental study to compare the effects of four different signs on NRLEV users at two grocery stores, Store A and Store B, in the same city mentioned in Study One. We replaced the current “Van Accessible” sign with four specially designed signs with different messages, alternating the signs over a four-month observation period.

**Findings:** The signage interventions had small to moderate effects in deterring NRLEV users from parking in designated van-accessible parking spaces. The “Please Be Courteous” sign was most effective

at Store A; the “Warning” sign was most effective at Store B.
